Kaleya Smallholders Company Ltd

Groundwater Assessment and Geophysical Survey

Project №. AQ22-003

31 March 2022

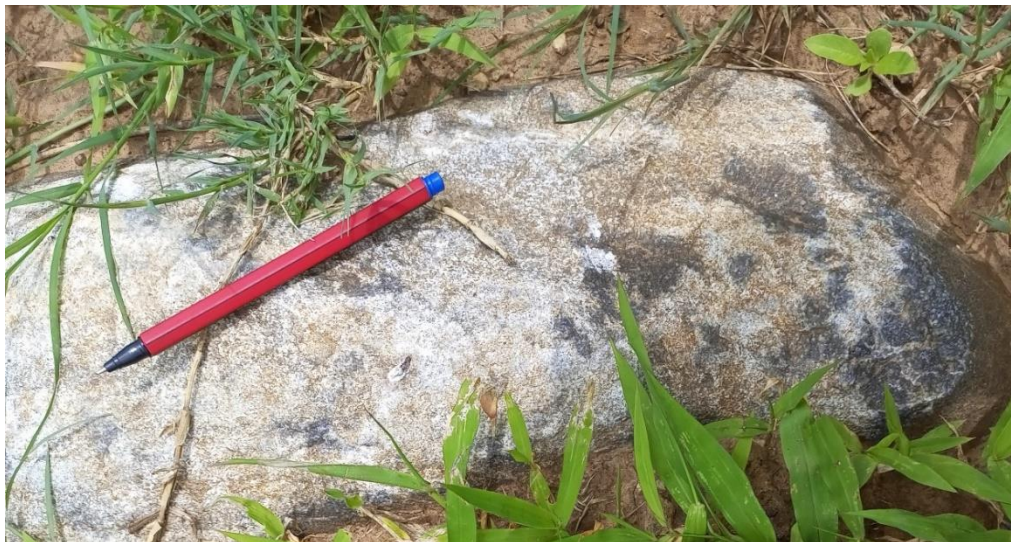
**Figure 7: Dolomite outcrop**

Some outcrops of dolomite were observed (Figure 7) in the northern parts of the Estate.

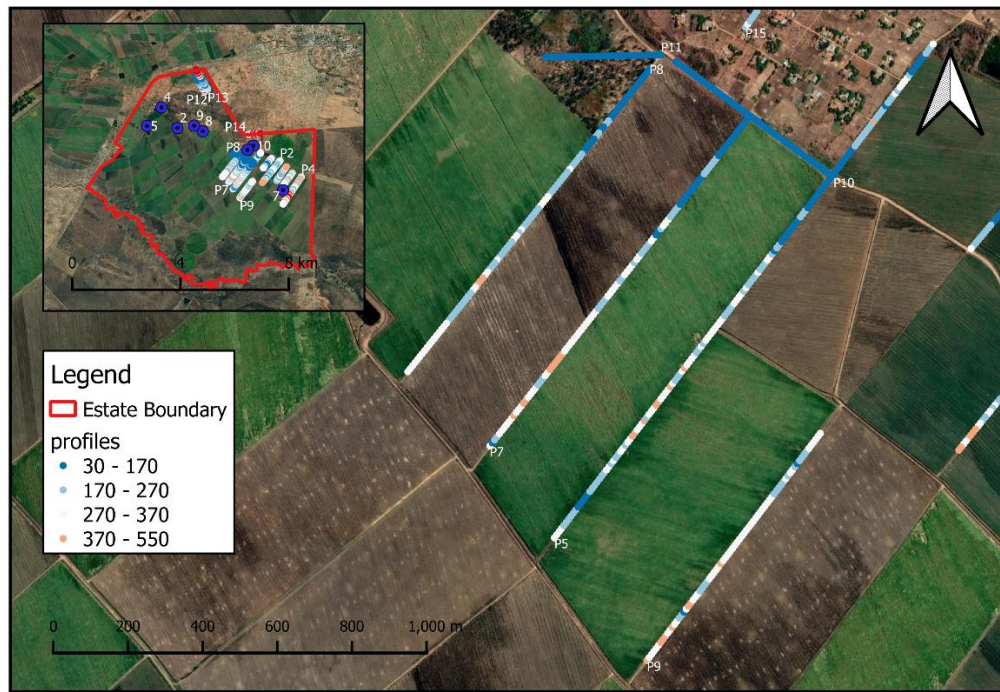
Figure 10: Geophysical profiles (5, 7-11)

Figure 9 to Figure 12 provide schematic overviews of the profile results, with low resistivities indicated in blue, and relatively high values shown in red color. Plotted field data (profile graphs) are included in Annex I.
